UNDERWATER BRIDGE INSPECTION REPORT

STRUCTURE NO. 6676

RED RIVER OF THE NORTH

MINNESOTA DEPARTMENT OF TRANSPORTATION
UNDERWATER BRIDGE INSPECTION

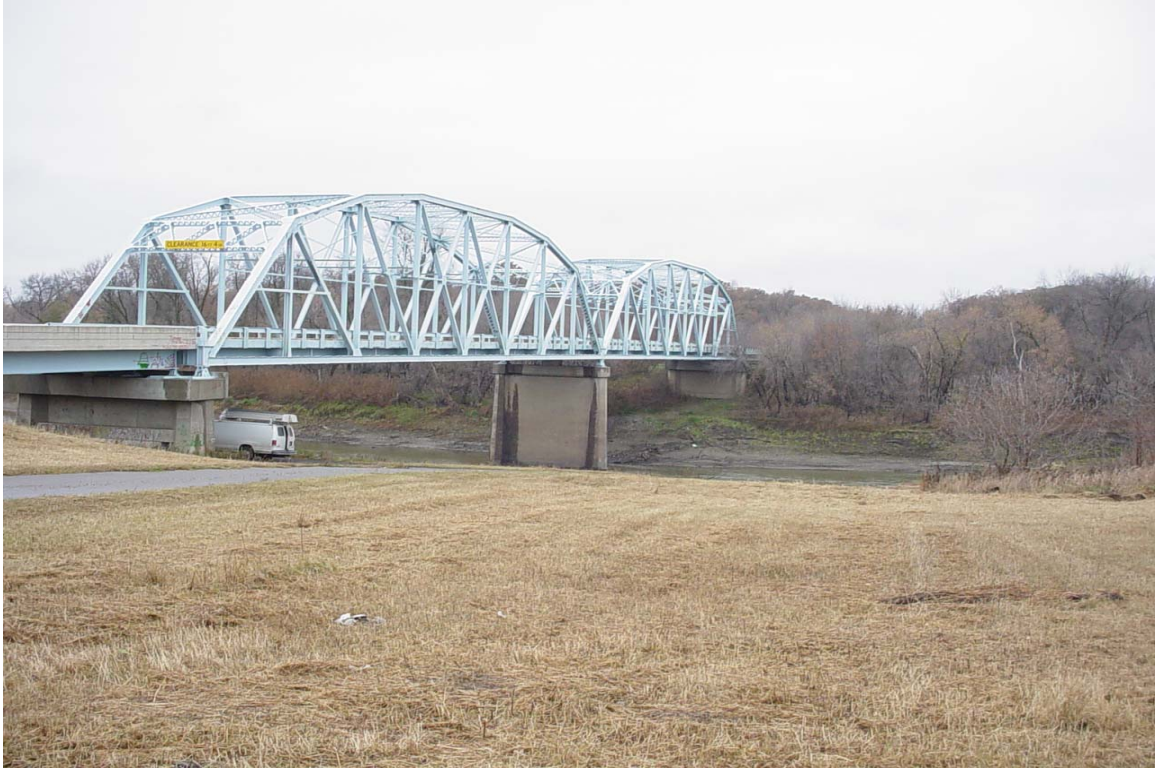
Photograph 1. Overall View of the Structure, Looking West.

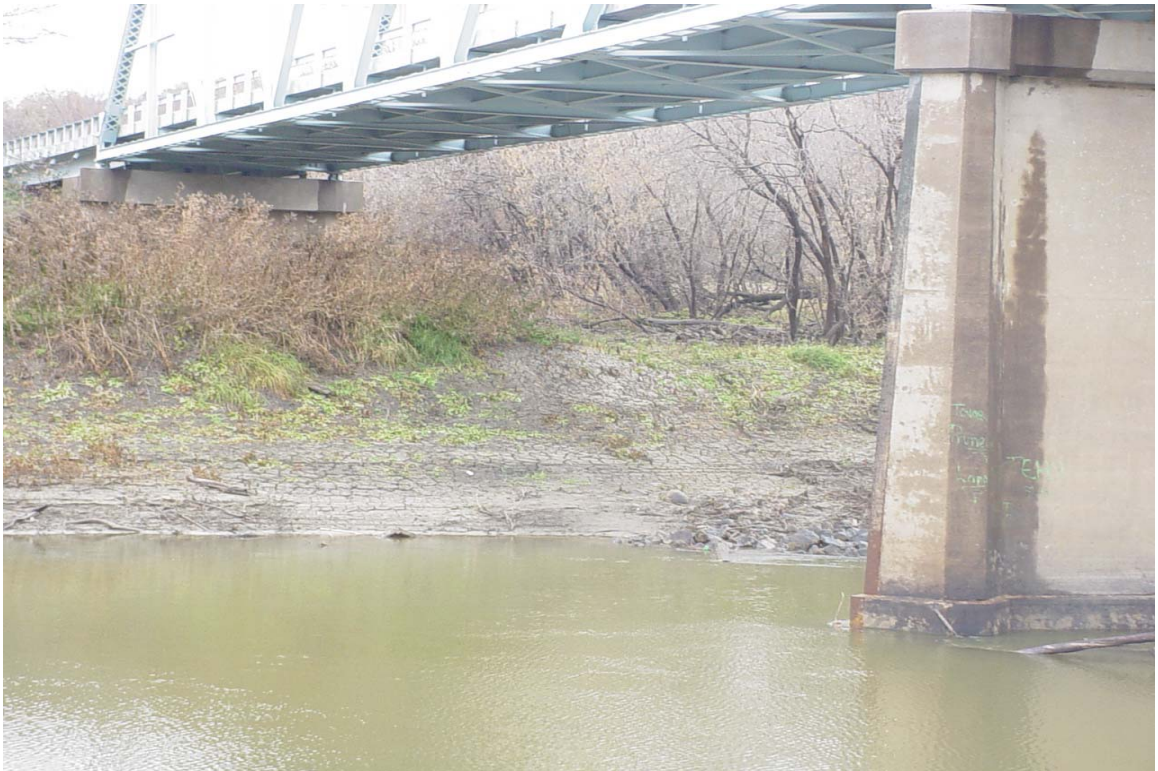
- (A) Adjacent to Pier 2 and extending towards the east bank, a moderate accumulation of timber debris consisting of large tree branches and logs up to 1 foot in diameter was present, extending from 1 foot above the waterline to the channel bottom. The accumulation extended to across the upstream nose of Pier 2 and along most of the easterly side of the shaft.
- (B) Numerous abandoned timber piles were present along the eastern shoreline. Most of these piles were cut-off approximately 3 feet above the waterline, and were trapping timber drift and causing it to accumulate.
- (C) The east bank was heavily eroded upstream and downstream of the bridge.

Photograph 2. Overall View of the West Bank, Looking Northwest.
